Manhole Inspection Summary

Manhole # S35A__025MH

Inspection ☐ Is Incomplete Rating: **5) Immediate Attention Required**

Location Address: **401 GUILFORD AV**

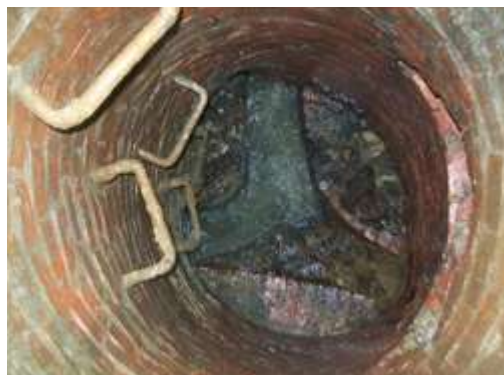
Top View

damage to barrel wall can be seen above 4 O'clock connection

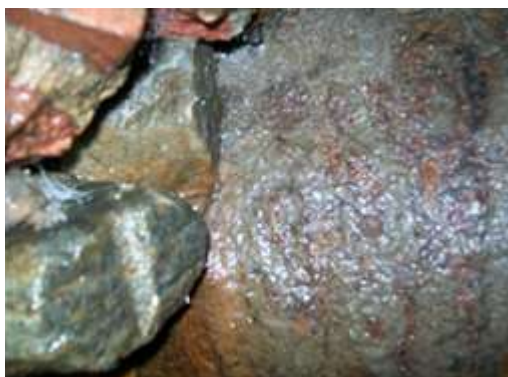
Misc.

DAMAGE TO STRUCTURE FROM
CONCRETE PIPE INSTALLATION
(Additional View)

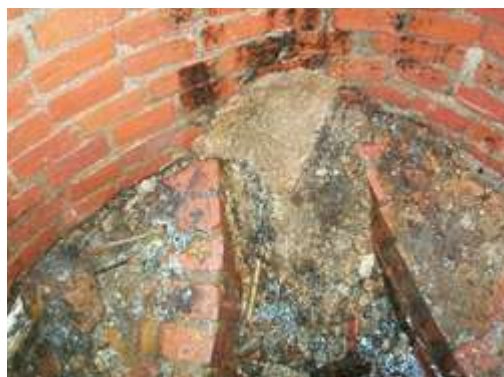
Defect 7

☒ **Wall**

INFILTRATION @ BARREL WALL

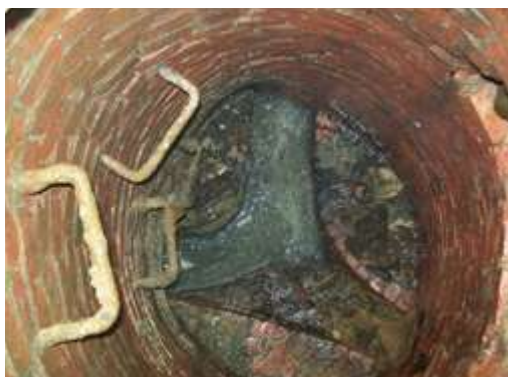
Defect 6

☒ **Debris**

DEBRIS ON BENCH

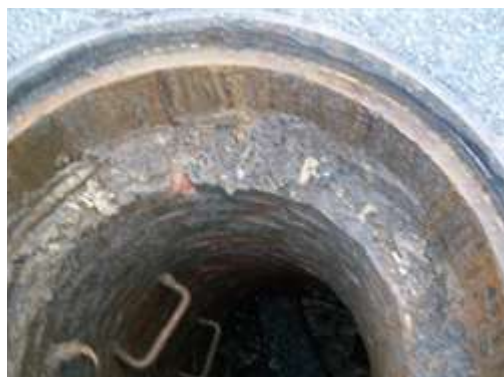
Defect 5

☒ **Leaks**

FRAME LEAKS

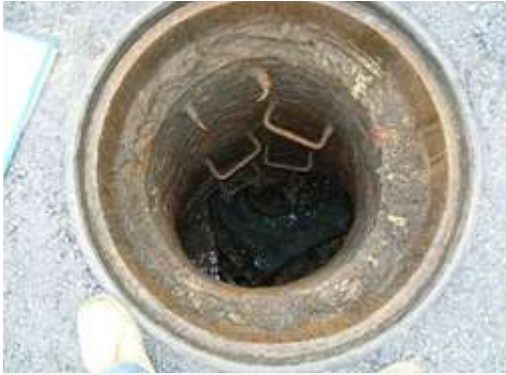
Defect 4

Offset: **3** (in.)

FRAME OFFSET

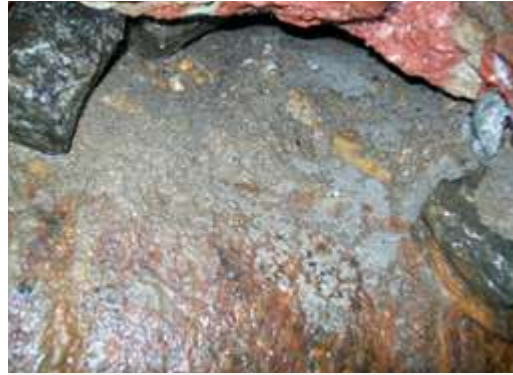
Defect 3

DETERIORATED BARREL BRICKS -
RCCP STORM DRAIN ON OTHER SIDE

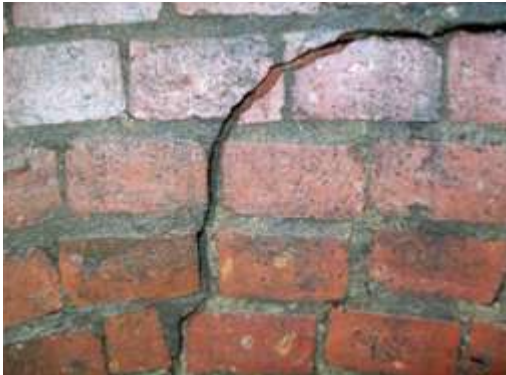
Defect 2

CRACKED/FRACTURED BARREL
BRICKS

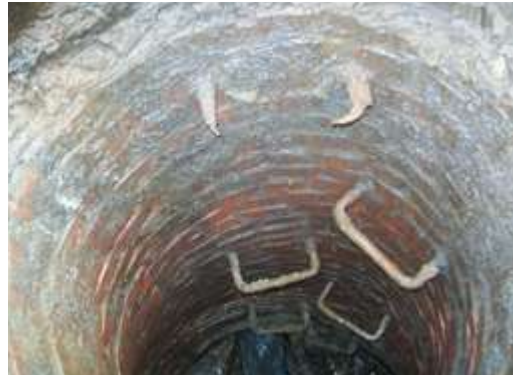
Defect 1

Missing: **1**

☒ **Corroded**

DETERIORATED/MISSING STEPS

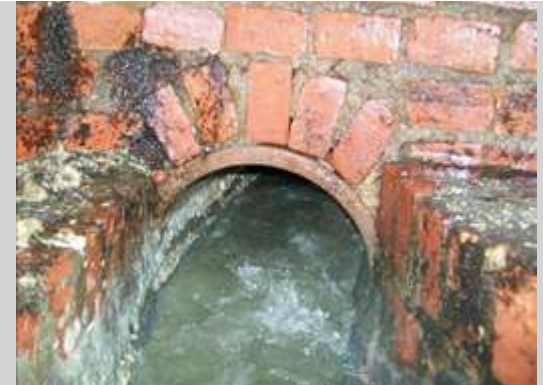
12 O'Clock Outflow

Pipe Height: **12** (in.) Rod and Bar (Angled)
Pipe Material: **Clay** ☐ Pipe Lined
Invert Depth: **10.81** (ft.) Flow Characteristics: **Fast**
Deposits: ☐ None ☐ Mud ☐ Sludge ☐ Debris ☒ Grease
Silt Depth: **1** (in.) Deposits Extent: **Light**
Infiltration: **None** Pipe Seal Cond: **Sound**

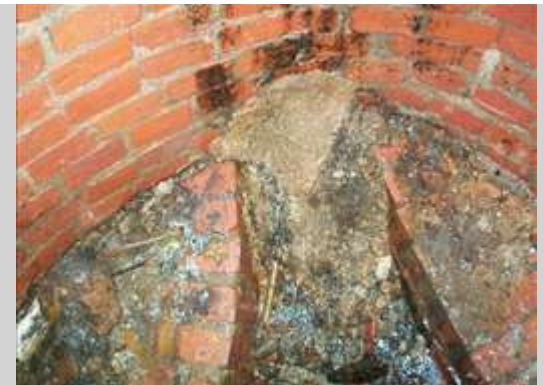
4 O'Clock Inflow

Connects To: **Stub connection / abandoned**
